**Antlers at Vail  
Vail, CO**

Report #: 13433-3  
Beginning: October 1, 2023  
Expires: September 30, 2024

**RESERVE STUDY  
Update "With-Site-Visit"**

April 20, 2023

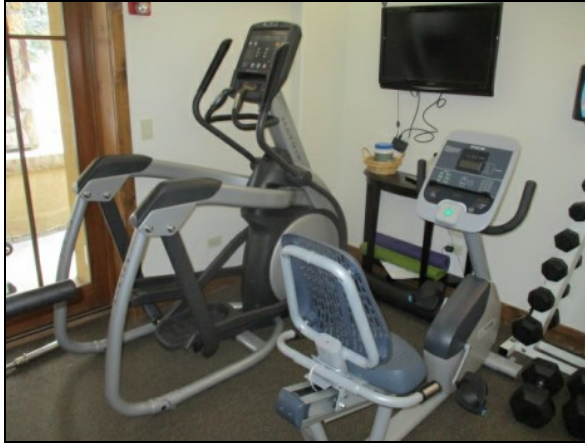
Comments: Includes (1) Treadmill, (1) Stationary Bike, (1) Elliptical. Fitness equipment determined to be in poor condition typically exhibits more advanced signs of wear and usage, such as rusting on exposed surfaces, deterioration at handgrips, malfunctioning electronics, etc. If equipment is still in usable physical condition, replacement may still be warranted in order to upgrade to more modern technology that would be more appropriate for the property.

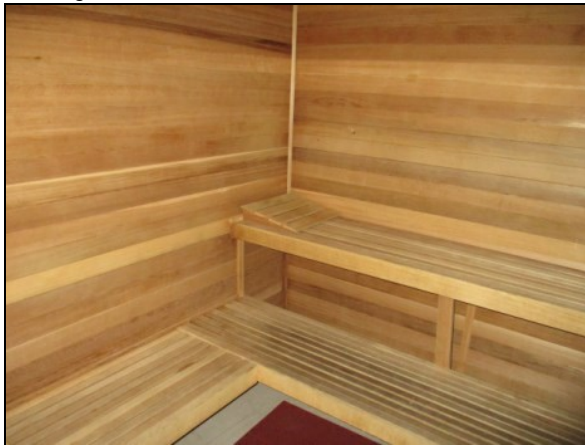
Comments: Sauna rooms determined to be in fair condition typically exhibit routine signs of use and some light deterioration to wood surfaces, but no major wear or splintering. Appearance is still consistent overall. Clean, inspect and repair as needed as an Operating expense. Life expectancy can vary greatly depending on level of use and aesthetic preferences. Funding recommendation shown here is based on our experience with similar properties. Timing of remodeling is ultimately subjective. Best practice is to coordinate remodeling with other amenities, such as bathrooms or other facilities.
