**Antlers at Vail  
Vail, CO**

Report #: 13433-3  
Beginning: October 1, 2023  
Expires: September 30, 2024

**RESERVE STUDY  
Update "With-Site-Visit"**

April 20, 2023

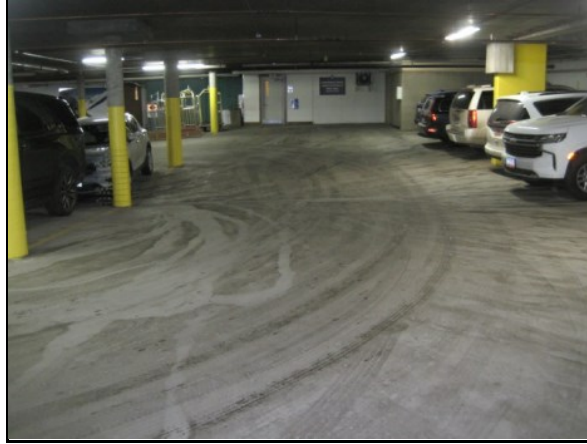
Useful Life:  
10 years

Remaining Life:  
4 years

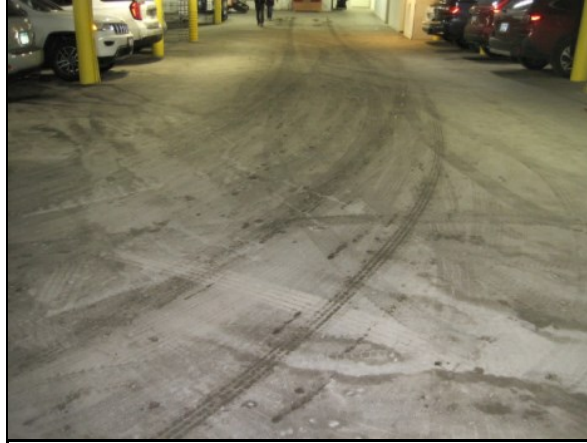
Useful Life:  
10 years

Remaining Life:  
0 years

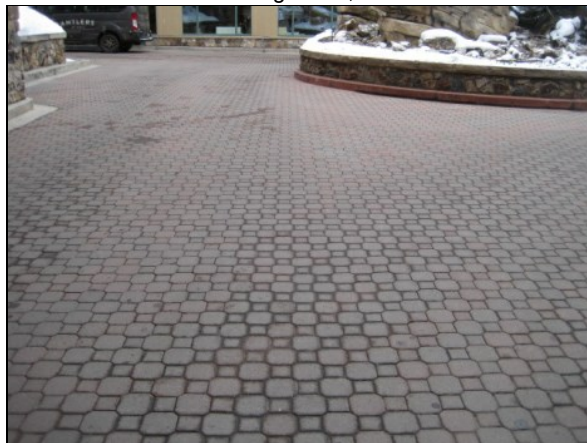
Useful Life:  
30 years

Remaining Life:  
8 years

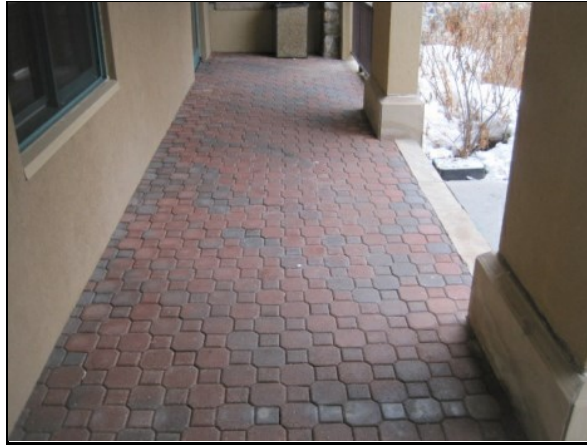
Useful Life:  
10 years

Remaining Life:  
3 years

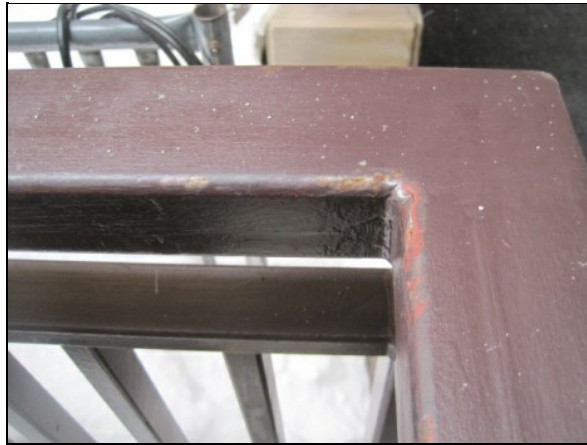
Useful Life:  
5 years

Remaining Life:  
0 years

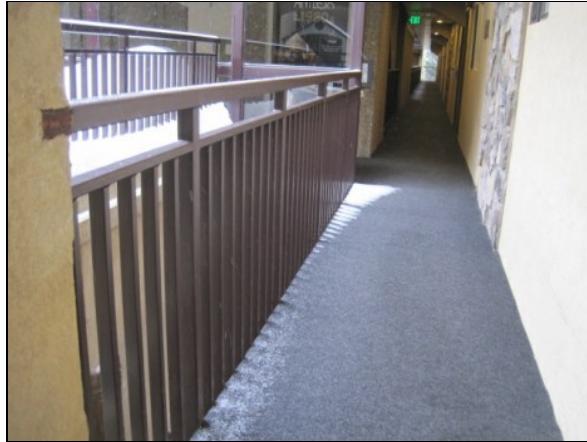
Useful Life:  
40 years

Remaining Life:  
18 years

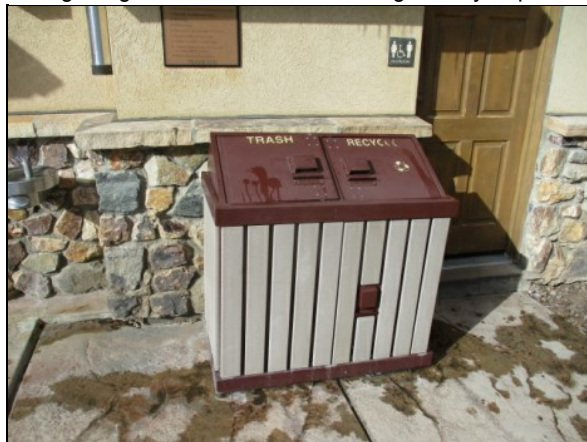
Useful Life:  
20 years

Remaining Life:  
3 years

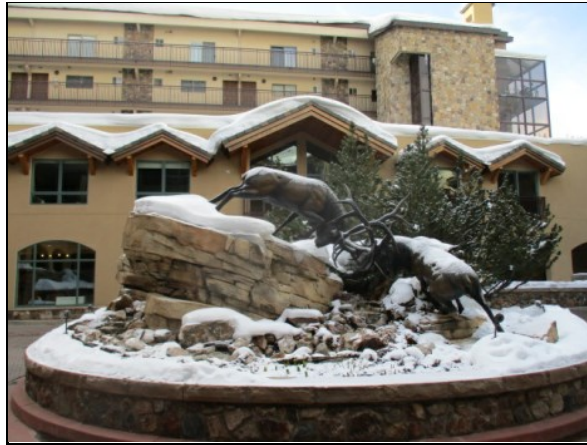
Useful Life:  
30 years

Remaining Life:  
8 years

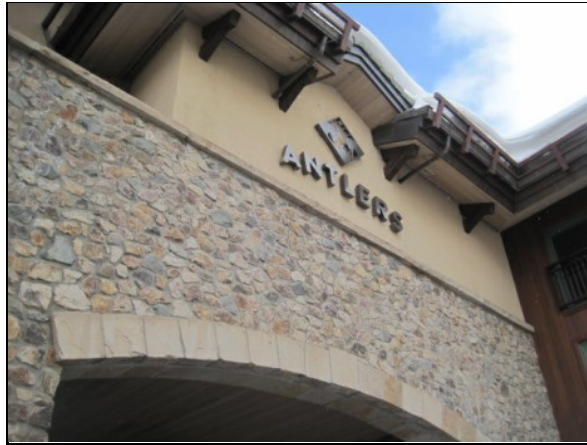
Useful Life:  
30 years

Remaining Life:  
8 years

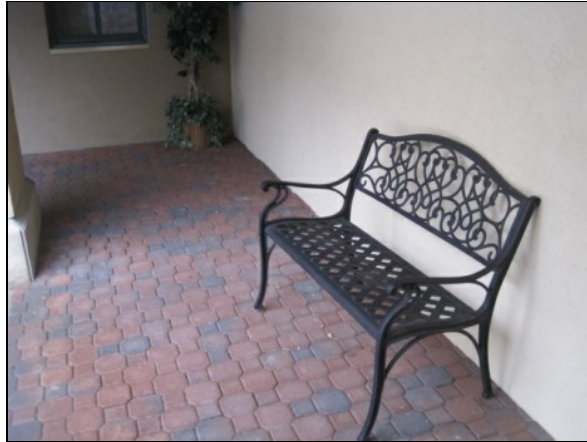
Useful Life:  
10 years

Remaining Life:  
0 years

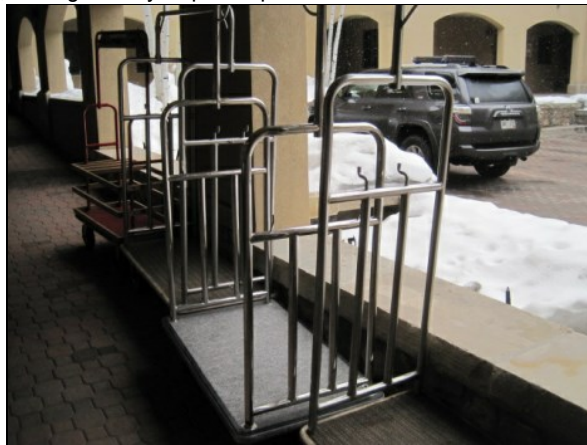
Useful Life:  
10 years

Remaining Life:  
7 years

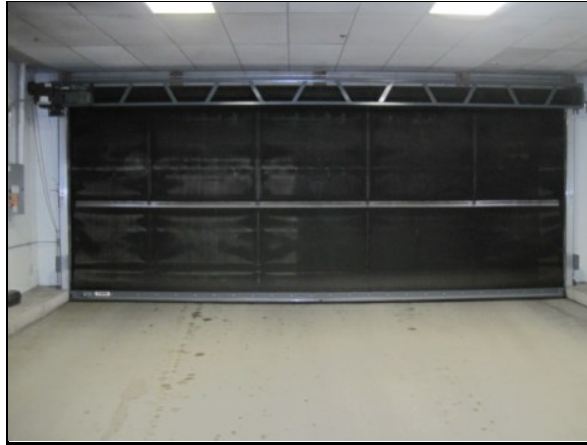
Useful Life:  
20 years

Remaining Life:  
12 years

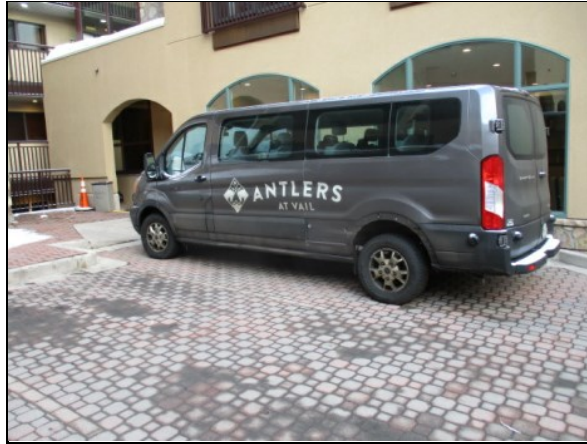
Useful Life:  
12 years

Remaining Life:  
3 years

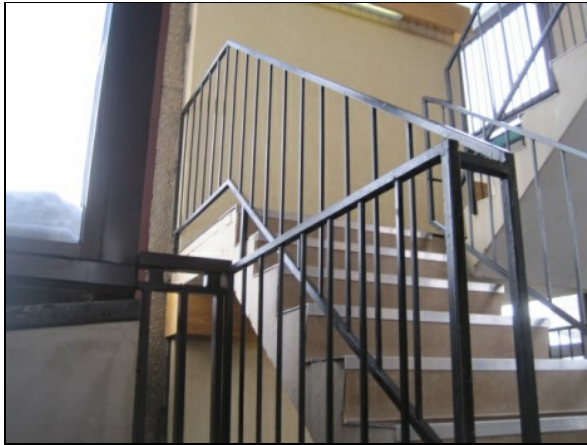
Remaining Life:

0 years

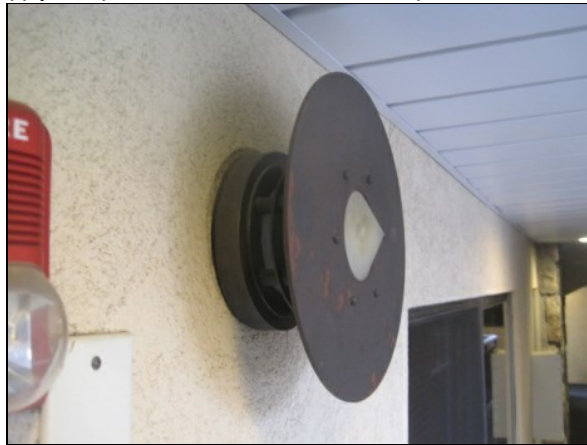
Useful Life:  
25 years

Remaining Life:  
3 years

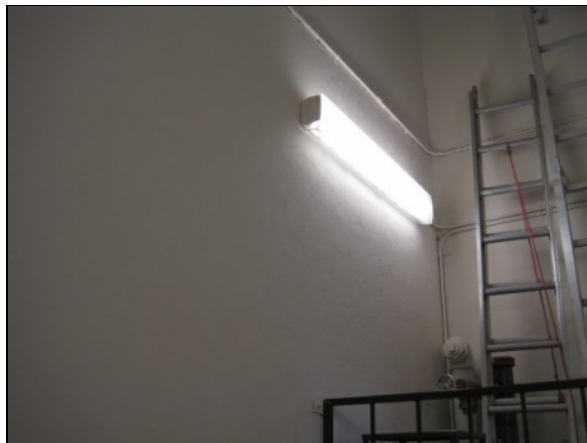
Useful Life:  
25 years

Remaining Life:  
3 years

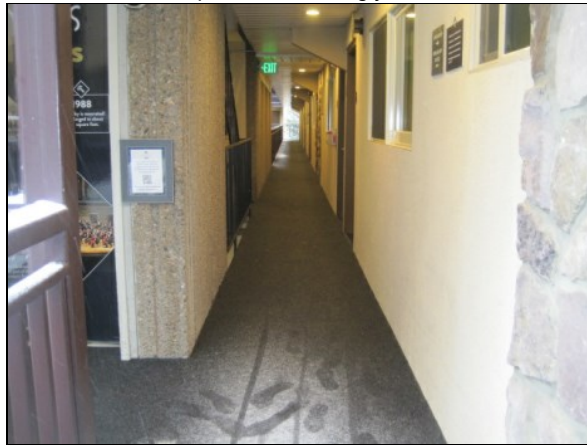
Useful Life:  
10 years

Remaining Life:  
6 years

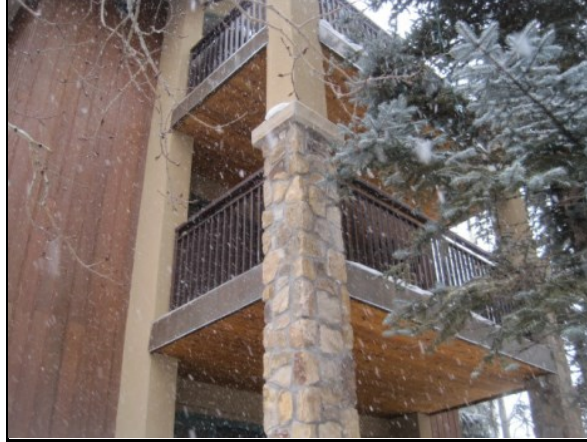
Useful Life:  
5 years

Remaining Life:  
2 years

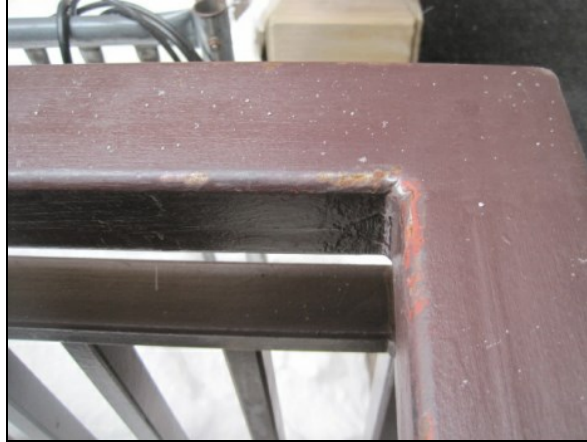
Useful Life:  
5 years

Remaining Life:  
0 years

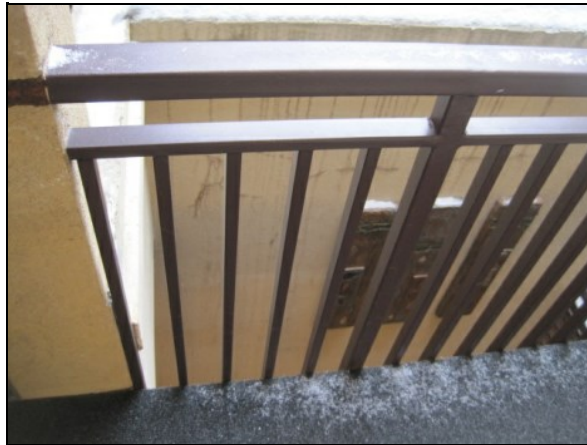
Useful Life:  
40 years

Remaining Life:  
18 years

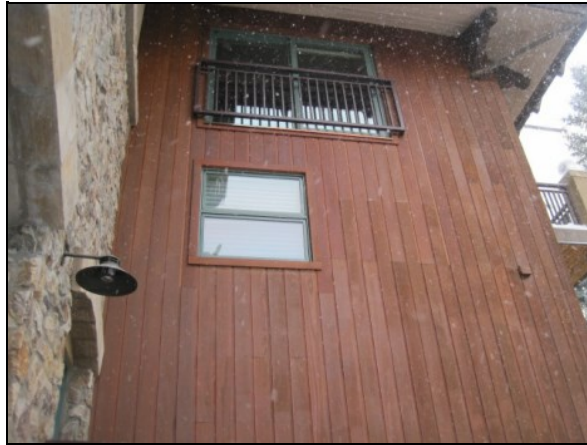
Useful Life:  
5 years

Remaining Life:  
1 years

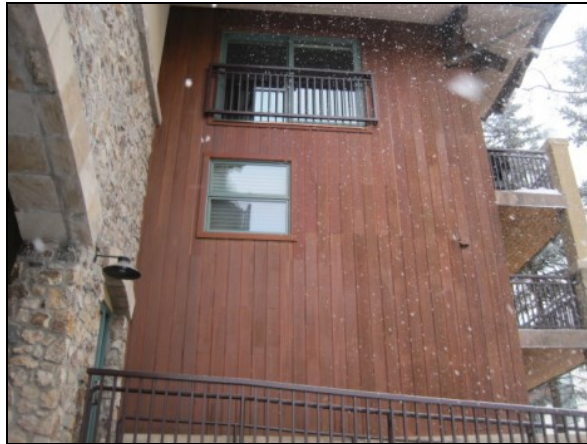
Useful Life:  
50 years

Remaining Life:  
28 years

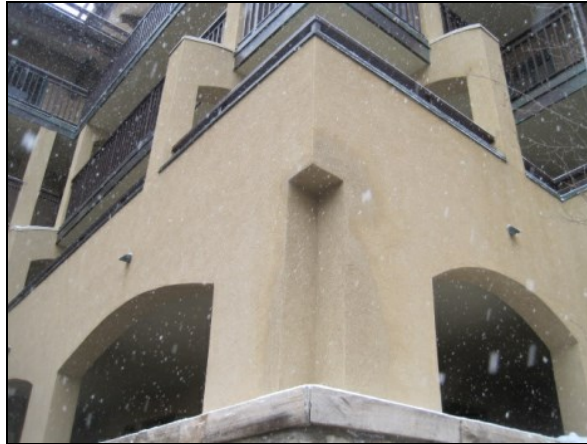
Useful Life:  
15 years

Remaining Life:  
0 years

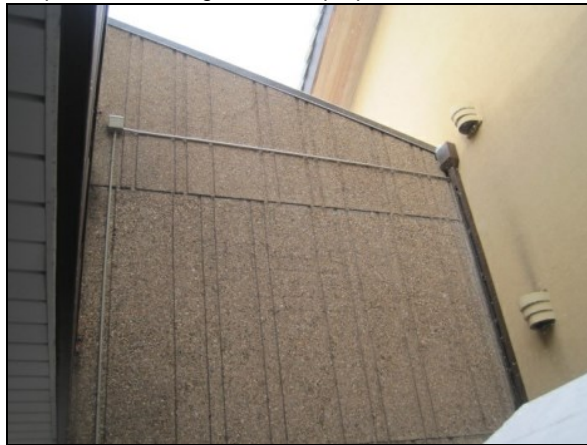
Useful Life:  
20 years

Remaining Life:  
0 years

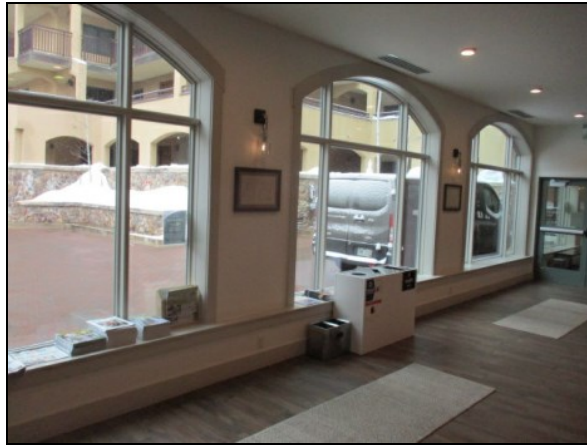
**Comp #: 23440 Windows (Common) - Replace**

Comments: Windows determined to be in good condition typically exhibit only minor routine signs of wear and age. Frames appear to be intact with no significant pitting or other surface wear. All moving parts appear to be functional and glass appears to be clear and free from damage. Windows were metal. Inspect regularly including sealant if any and repair as needed. Proper sealant/caulking is critical to keeping water out of the walls and preventing water damage. With ordinary care and maintenance useful life is long but difficult to predict. Many factors affect useful life including quality of window installed waterproofing flashing details exposure to wind driven rain. In many cases windows are replaced on an ongoing basis to select areas as-needed rather than to an entire building at one time. This component should be re-evaluated as the building ages and more problems develop and funding recommendations should be adjusted accordingly. An allowance for partial replacements may be warranted if certain windows are more deteriorated than others. Consult with vendors to ensure replacement windows are compliant with all applicable building codes. Note there are many types of windows available in today's market and costs can vary greatly.

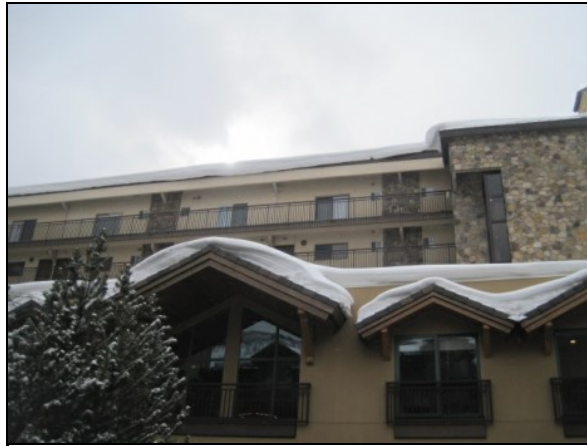
**Comp #: 23540 Roof: Modified Bitumen - Replace**

Comments: Modified bitumen built up roofs determined to be in fair condition and typically exhibit normal signs of wear for the age of the roof. These characteristics may include some loss of granule cover, evidence of ponding, blisters or wrinkles, etc. At this stage, leaks may become more frequent but roof is overall believed to be aging normally. Our inspection is limited to a visual evaluation of accessible areas and is not a substitute for a comprehensive inspection including destructive testing, sub-surface moisture evaluation, core sampling, etc. The typical useful life of a flat (AKA "low-slope") roof will vary depending on the quality of the roof system installed, weather/storm activity, and the maintenance receives throughout its life. As routine maintenance, many manufacturers recommend professional roofing inspections at least twice annually and after storms. We generally recommend consideration of ongoing roof maintenance contracts with professional vendors. Ongoing routine inspections by maintenance personnel are also advisable, to remove accumulated debris, clear drains and inspect for minor problems. Keep all drainage elements (scuppers, drains, gutters/downspouts, etc.) clear to allow proper drainage and prevent the ponding of water on the roof surface. We also recommend using walk pads or extra roofing material to provide pathways in high-traffic areas, such as around any HVAC units or other equipment. Take care to minimize any penetrations in the roof system. Rooftop satellite dishes or other equipment should not be permanently mounted into the roof if avoidable; most equipment can instead be weighed down by concrete blocks or other ballast. All penetrations including drains, vent pipes, conduit, etc. should be carefully flashed and waterproofed. For more information, we recommend consulting with independent roofing consultants or with organizations such as the Roof Consultant Institute <http://www.rci-online.org/> and the National Roofing Contractors client (NRCA) <http://www.nrca.net/>. If the roof has a warranty, be sure to review terms and conduct proper inspections/repairs as needed to keep warranty in force.

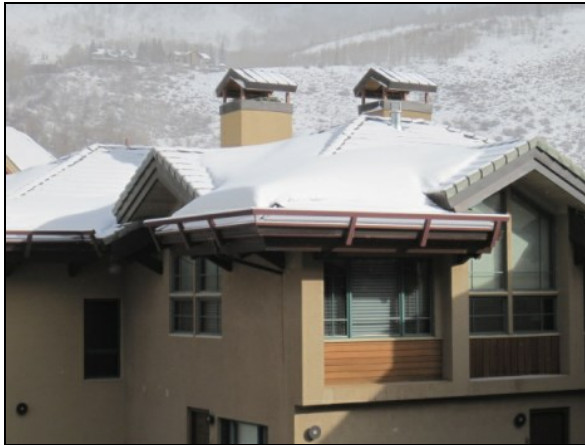
**Comp #: 23590 Roof: Tile Underlayment - Replace**

Comments: Open valleys with copper flashing observed. Visible portions of roof flashing were observed at the rake, headwall, and sidewall. Debris was not observed on the roof surface. A reserve study conducts only a limited visual review, and many of the critical waterproofing and ventilation items of the roof are not readily viewable. For a full evaluation have a professional roof consultant/contractor perform a thorough up-close survey of your entire roof system, including attic inspection (if any). Concrete or clay tile can last in the 50-75 year range, but the underlayment and the wood battens beneath the roofing will likely need to be replaced sooner. As routine maintenance, many manufacturers recommend inspections at least twice annually (once in the fall before the snow season and again in the spring) and after large storm events. Promptly replace any damaged/missing sections or any other repair needed to ensure waterproof integrity of roof. Keep roof surface, gutters, and downspouts clear and free of debris. The majority of tile roofs are installed with minimum standards including the lowest grades of underlayment and flashings. Standard underlayment has a general useful life of about 25 years, depending on climate exposure and moisture content. At the time of re-roofing, we recommend that you hire a professional consultant to evaluate the existing roof and specify the new roof materials/design, provide installation oversight. We recommend that all clients hire qualified consultants whenever they are considering having work performed on any building envelope (waterproofing) components including: roof, walls, windows, decks, exterior painting, and caulking/sealant. The National Roofing Contractors client (NRCA) has additional information available on their web site <http://www.nrca.net/Consumers/>. Information regarding the difference between the expected life of the tiles and the expected life of the underlayment and flashings can be found at <https://www.reservestudy.com/lifetime-tile-roofs-fact-or-fiction>.

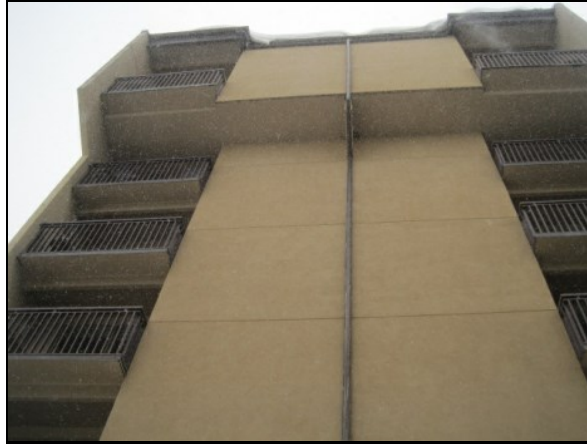
**Comp #: 23650 Gutters/Downspouts - Replace (2002)**

Comments: Gutters and downspouts determined to be in fair condition typically exhibit some normal wear and tear, but drainage away from the roof and building appears to be adequate. Generally believed to be aging normally. Gutters and downspouts are assumed to be functioning properly unless otherwise noted. As routine maintenance, inspect regularly, keep gutters and downspouts free of debris. If buildings are located near trees, keep trees trimmed back to avoid accumulation of leaves on the roof surface which will accumulate in the gutters and increase maintenance requirements while reducing life expectancy. Repair or replace individual sections as needed as an Operating expense. We generally recommend that the gutters and downspouts be replaced when the roof is being resurfaced/replaced. National Roofing Contractor client (NRCA) roofing standard includes installing eave flashings at the gutters. We suggest to plan for total replacement of gutter and downspouts at the same intervals as roof replacement for cost efficiency. Unless otherwise noted, costs shown here assume replacement with similar type as are currently in place.

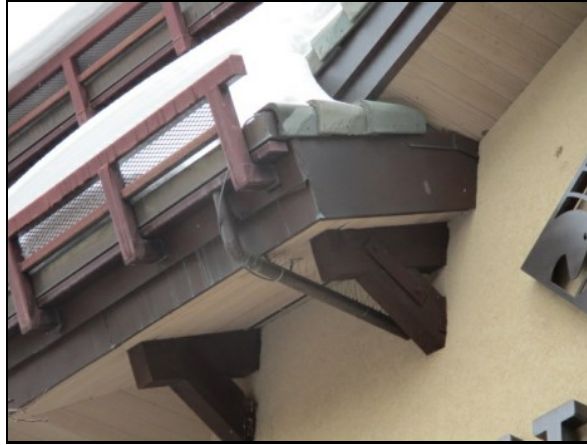
**Comp #: 23650 Gutters/Downspouts - Replace (2011)**

Comments: Gutters and downspouts determined to be in fair condition typically exhibit some normal wear and tear, but drainage away from the roof and building appears to be adequate. Generally believed to be aging normally. Gutters and downspouts are assumed to be functioning properly unless otherwise noted. As routine maintenance, inspect regularly, keep gutters and downspouts free of debris. If buildings are located near trees, keep trees trimmed back to avoid accumulation of leaves on the roof surface which will accumulate in the gutters and increase maintenance requirements while reducing life expectancy. Repair or replace individual sections as needed as an Operating expense. We generally recommend that the gutters and downspouts be replaced when the roof is being resurfaced/replaced. National Roofing Contractor client (NRCA) roofing standard includes installing eave flashings at the gutters. We suggest to plan for total replacement of gutter and downspouts at the same intervals as roof replacement for cost efficiency. Unless otherwise noted, costs shown here assume replacement with similar type as are currently in place.

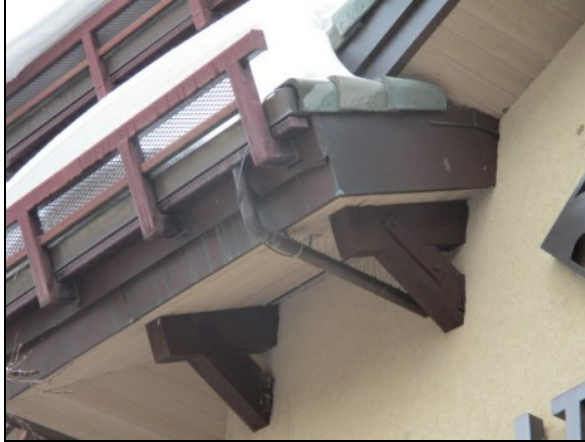
**Comp #: 23660 Heat Tape - Replace**

Comments: The heat tape was reported to be in poor condition. Based upon the age of the heat tape, plan to replace soon. Heat tape was observed along the edges of the roof and the downspouts. Heat tape generally follows the length of the gutter and downspouts. Heat cables, when installed and functioning properly, will help offset the likelihood of an ice dam. Heat tape, on average, creates an output between 50-70°F. When installed in the gutters, the heat cables can keep your gutters and downspouts from collecting and freezing with ice and snow melt.

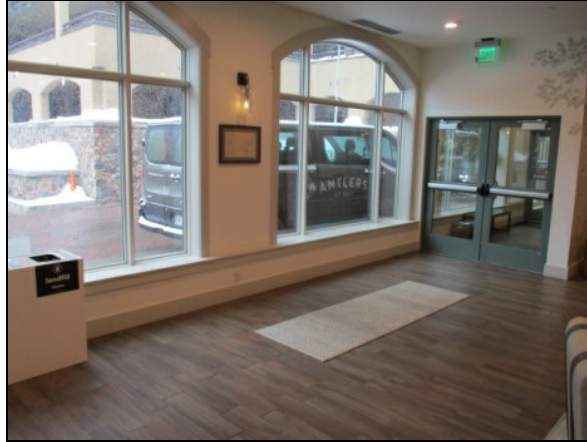
### Comp #: 23480 Exterior Doors - Replace

Comments: Utility doors determined to be in good condition typically exhibit minor normal signs of wear and tear. Frame hardware and hinges are free from significant rust and corrosion and doors generally appear to open and close easily. Utility doors should have a very long useful life expectancy in most cases. However occasional replacements may be required especially for doors located in more exposed areas. Inspect periodically and repair as needed to maintain appearance security and operation with maintenance funds. Should be painted along with building exteriors or other painting/waterproofing projects to preserve appearance and prolong useful life. Based on our experience with comparable properties we recommend planning for ongoing partial replacements at the approximate interval shown here.

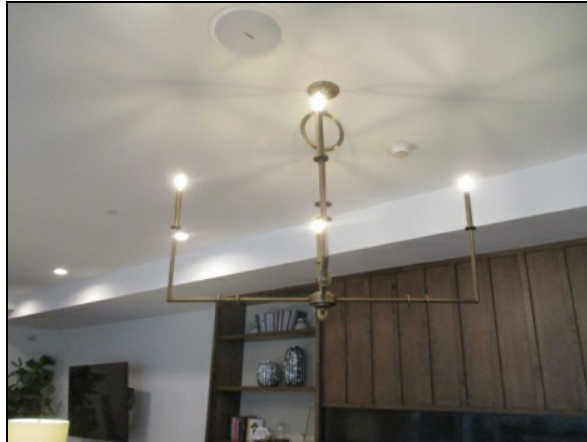
**Comp #: 24030 Interior Lights - Replace**

Comments: Includes (2) Chandelier, (7) Sconces. Interior wall lights were noted to be in good condition with no significant damage/deterioration observed or reported to us. As routine maintenance inspect repair and change bulbs as needed. Best practice is to coordinate at same time as other interior projects (especially painting) whenever possible to minimize downtime and maintain consistent quality standard. Timing of replacements is ultimately subjective. Estimates shown here are based on our experience with similar properties and general aesthetic qualities. A wide variety of fixture styles is available funding recommendations are based on replacement with comparable quality fixtures.

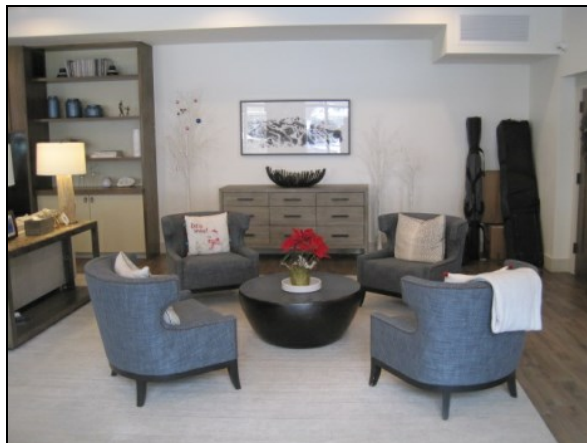
Comments: Includes (2) Lamps, (10) Upholstered Chairs, (2) Upholstered Sofas, (4) Wall Tables, (6) Chairs, (1) Table. The furniture and decor appeared in generally good to fair condition. No damage fading or outdated appearances of the furniture was observed. This component recommends funding for periodic replacement/refurbishment of interior furnishings and decor such as furniture artwork window treatments misc. decorative items etc. in order to maintain a desirable aesthetic in the common areas. Cost estimates can vary greatly depending on the amount of items to be replaced at each project and the style and quality of replacement options. Best practice is to coordinate this type of project with other interior projects such as flooring replacement painting etc. Schedule and cost estimates should be re-evaluated during future Reserve Study updates and adjusted as needed based on the client's good judgment.

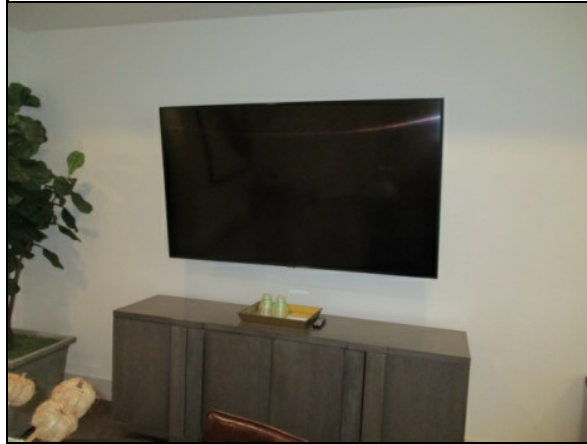
**Comp #: 24230 A/V Equipment – Update/Replace**

Comments: Includes (1) TV in Lobby, (4) TVs in Offices, (1) TV in Conference Room. Minimal or no subjective/aesthetic value for this sauna heater. Useful life is based primarily on normal expectations for service/performance life in this location. Unless otherwise noted, remaining useful life expectancy is based primarily on original installation or last replacement/purchase date, our experience with similar systems/components, and assuming normal amount of usage and good preventive maintenance.

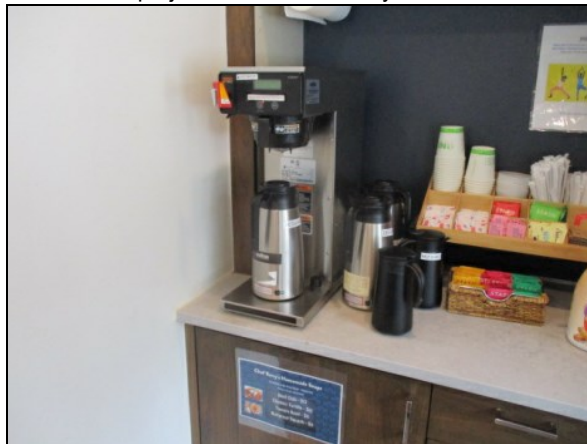
Comments: Includes (10) GSF of Counters, (5) LF of Base Cabinets, (1) Lavazza Espresso Machine, (1) Bunn Coffee Maker. Coffee bar was observed to be in good condition. Counters and cabinets were clean and free of issues. Fixtures appeared to be in good condition. Materials typically have an extended useful life. However many clients choose to refurbish the kitchen periodically for aesthetic updating. This may include refurbishment/refinishing of kitchen cabinets and countertops replacement of sinks installation/replacement of under-cabinet lighting etc. Should ideally be coordinated with replacement of the kitchen appliances. Best practice is to coordinate this project with other amenity areas such as bathrooms or other amenity rooms.

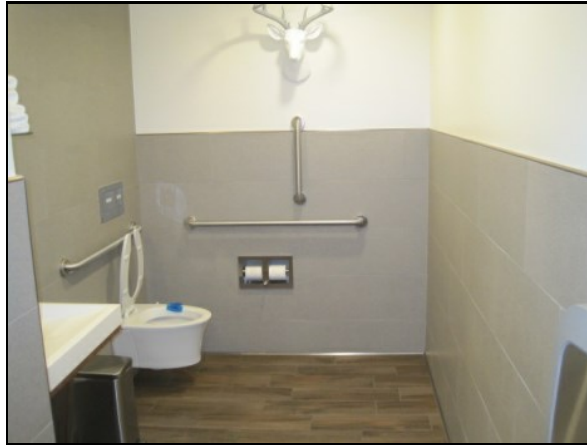
Comments: Includes (110 GSF) Tile, (192 GSF) Wall Tile, (256 GSF) Surfaces. Bathrooms were determined to be in good to fair condition. Flooring did not exhibit any un-even or broken sections. Fixtures appeared to be in good condition. As routine maintenance inspect regularly and perform any needed repairs promptly utilizing general Operating funds. Typical remodeling project can include some or all of the following replacement of plumbing fixtures partitions countertops lighting flooring ventilation fans accessories decor etc. Best practice is to coordinate this type of project with other areas whenever possible. Schedule and cost estimates should be re-evaluated during future Reserve Study updates and adjusted as needed based on the client's good judgment.

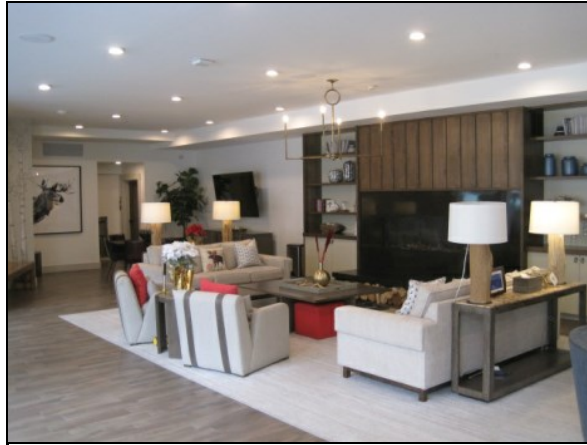
Comments: Includes (3630 GSF) Surfaces, (2100 GSF) Engineered Hardwood, (1) TV, (1) Fireplace. Lobby was observed to be in good condition. Flooring was clean and free of issues. Fixtures appeared to be in good condition. Lobby remodeling is prudent in order to maintain an attractive desirable appearance for existing owners as well as potential buyers and other guests. Typical projects often include replacement of finishes and furnishings artwork lighting etc. Life estimates can vary greatly depending on level of wear and preferences of client. Costs can vary greatly depending on types of materials selected for replacement. Many clients choose to work with design personnel to maintain a coordinated attractive aesthetic. Funding recommendation shown here is for remodeling to an appropriate standard for this client. Life and cost estimates should be re-evaluated during future Reserve Study updates.

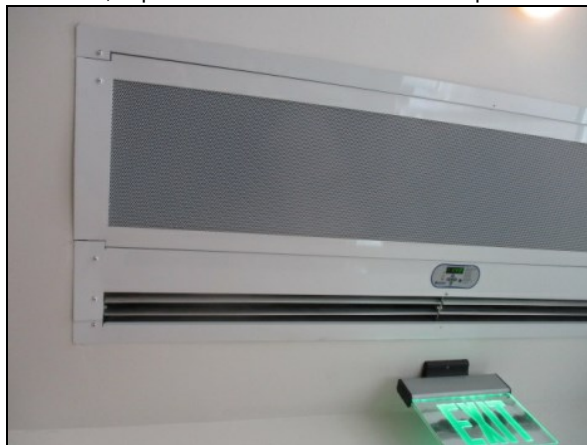
**Comp #: 25000 Mechanical Heat Curtain - Replace**

Comments: Minimal or no subjective/aesthetic value for this component. Useful life is based primarily on normal expectations for service/performance life in this location. Unless otherwise noted, remaining useful life expectancy is based primarily on original installation or last replacement/purchase date, our experience with similar systems/components, and assuming normal amount of usage and good preventive maintenance. Life expectancies can vary greatly depending on level of use, type of technology, amount of preventive maintenance and other factors. Should be inspected and repaired as needed by servicing vendor or maintenance staff. Unless otherwise noted, expected to be functional. Plan to replace at the approximate interval shown below.

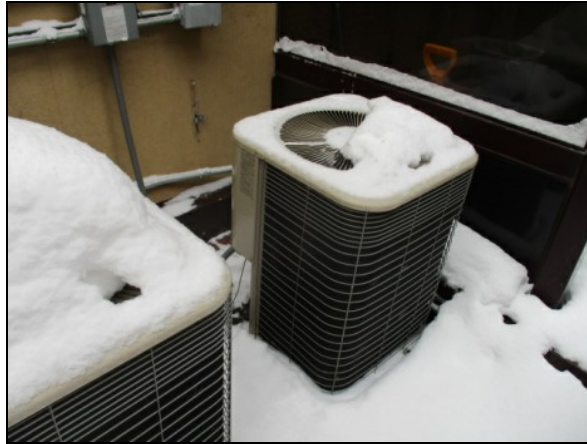
**Comp #: 25190 Condensing Units – Replace - 30%**

Comments: Inventory includes (1) Lennox 2-Ton Condenser (S: 5801F27213), (3) Lennox 3-Ton Condensers (S: 5801E69625, (3) Lennox 2.5-Ton Condensers (S:5801F28063), (1) Mitsubishi 2-Ton Condenser (S: 02008234), (1) Goodman 2-Ton Condenser (S:130-628-6174). Minimal or no subjective/aesthetic value for this component. Useful life is based primarily on normal expectations for service/performance life in this location. Unless otherwise noted, remaining useful life expectancy is based primarily on original installation or last replacement/purchase date, our experience with similar systems/components, and assuming normal amount of usage and good preventive maintenance. We recommend that routine repairs and maintenance such as filter replacements, system flushing, etc. be budgeted as an Operating expense. Useful life can often be extended with proactive service and maintenance. Unless otherwise noted, funding for system with same size/capacity as the current system. For split systems, we recommend budgeting to replace the entire system (condensing unit and air handler) together in order to obtain better unit pricing and ensure maximum efficiency, refrigerant compatibility, etc. If additional costs are expected during replacement, such as for system reconfiguration or expansion, ductwork repairs, electrical work, etc. costs should be re-evaluated and adjusted as needed during future Reserve Study updates.

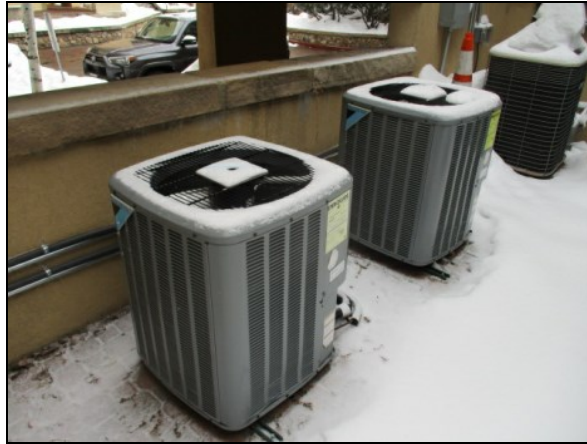
**Comp #: 25190 Condensing Units – Replace (2019)**

History: (2) Units replaced in 2019

Comments: Inventory includes (1) Lennox 2-ton system, serial number 5801F27213, (3) Lennox-3 ton unit, serial number 5801E69625, (3) Lennox 2.5-ton unit, serial number 5801F28063, (1) Mitsubishi 2-ton system serial number 02008234, and (1) Goodman, 2-ton system, serial number 130-628-6174 (replaced in 2013). Minimal or no subjective/aesthetic value for this component. Useful life is based primarily on normal expectations for service/performance life in this location. Unless otherwise noted, remaining useful life expectancy is based primarily on original installation or last replacement/purchase date, our experience with similar systems/components, and assuming normal amount of usage and good preventive maintenance. We recommend that routine repairs and maintenance such as filter replacements, system flushing, etc. be budgeted as an Operating expense. Useful life can often be extended with proactive service and maintenance. Unless otherwise noted, funding for system with same size/capacity as the current system. For split systems, we recommend budgeting to replace the entire system (condensing unit and air handler) together in order to obtain better unit pricing and ensure maximum efficiency, refrigerant compatibility, etc. If additional costs are expected during replacement, such as for system reconfiguration or expansion, ductwork repairs, electrical work, etc. costs should be re-evaluated and adjusted as needed during future Reserve Study updates.

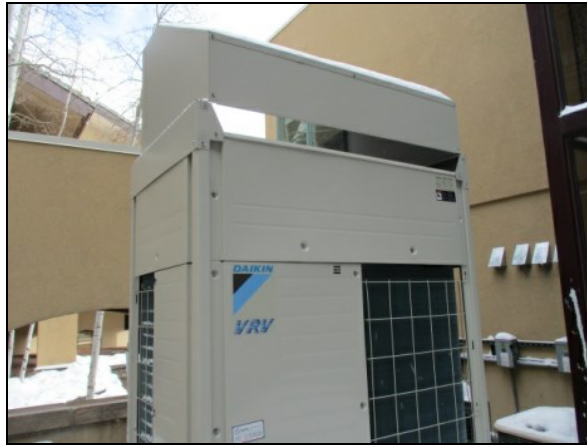
**Comp #: 25200 Heat Pump VRV - Replace**

Comments: Includes (1) Daikin VRV Heat Pump (M: RELQ72TATJU, S: 1906391057). Minimal or no subjective/aesthetic value for this component. Useful life is based primarily on normal expectations for service/performance life in this location. Unless otherwise noted, remaining useful life expectancy is based primarily on original installation or last replacement/purchase date, our experience with similar systems/components, and assuming normal amount of usage and good preventive maintenance. We recommend that routine repairs and maintenance such as filter replacements, system flushing, etc. be budgeted as an Operating expense. Useful life can often be extended with proactive service and maintenance. Unless otherwise noted, funding for system with same size/capacity as the current system. For split systems, we recommend budgeting to replace the entire system (condensing unit and air handler) together in order to obtain better unit pricing and ensure maximum efficiency, refrigerant compatibility, etc. If additional costs are expected during replacement, such as for system reconfiguration or expansion, ductwork repairs, electrical work, etc. costs should be re-evaluated and adjusted as needed during future Reserve Study updates.

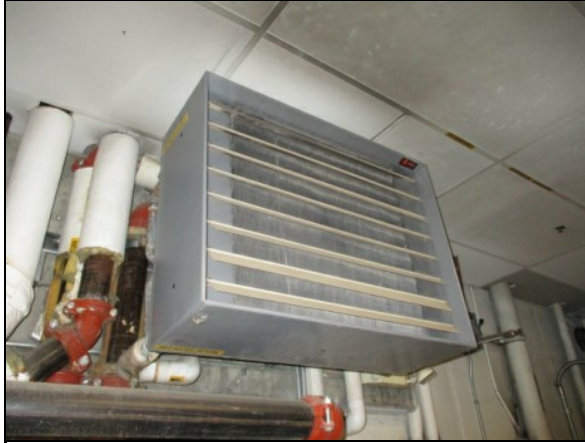
**Comp #: 25220 Space Heating - Replace**

Comments: Minimal or no subjective/aesthetic value for this component. Useful life is based primarily on normal expectations for service/performance life in this location. Unless otherwise noted, remaining useful life expectancy is based primarily on original installation or last replacement/purchase date, our experience with similar systems/components, and assuming normal amount of usage and good preventive maintenance. Heaters should be inspected and evaluated regularly by servicing vendor. In some cases, replacement is warranted due to lack of available replacement parts, or to upgrade to more efficient technology. Treat routine repairs/maintenance as an Operating expense. Plan for replacement at the typical service life expectancy indicated below. Useful life can often be extended with proactive service and maintenance. Unless otherwise noted, funding for system with same size/capacity as the current system.

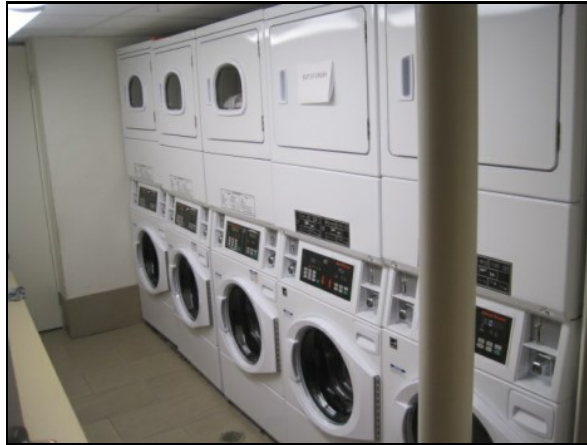
**Comp #: 25320 Guest Laundry Machines - Replace**

Comments: Minimal or no subjective/aesthetic value for this component. Useful life is based primarily on normal expectations for service/performance life in this location. Unless otherwise noted, remaining useful life expectancy is based primarily on original installation or last replacement/purchase date, our experience with similar systems/components, and assuming normal amount of usage and good preventive maintenance. Laundry machines should be inspected, serviced and repaired as needed by vendor and/or staff to ensure full useful life and achieve optimal performance. Useful life expectancy shown here assumes proper preventive maintenance and normal levels of use. Costs to replace are based on replacement with same-size units unless otherwise noted.

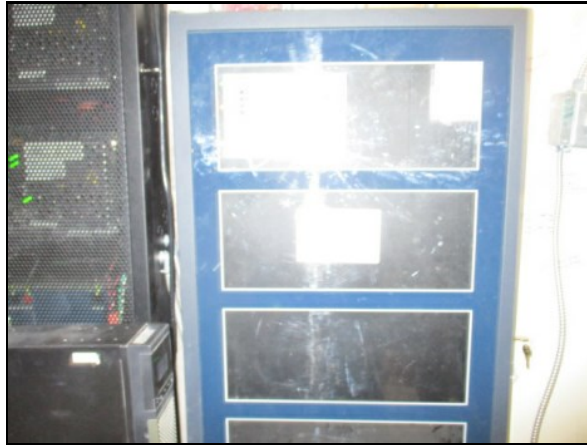
**Comp #: 25410 Fire Control Panel - Replace**

History: Replaced in 2020.

Comments: Includes (1) Notifier Panel. Our inspection is for planning and budgeting purposes only fire alarm equipment is assumed to have been designed and installed properly and is assumed to comply with all relevant building codes. Regular testing and inspections should be conducted as an Operating expense. In many cases, manufacturers discontinue support of equipment after a certain number of years, which may limit availability of replacement parts as the system ages. Cost estimates assume that existing wiring can be re-used and that only panel and devices will be replaced. If wiring requires replacement, estimates should be increased accordingly, but in our experience wiring should have an indefinite useful life. Cost estimates are based on quantity and type of existing equipment, not including any expansion or upgrades, which may be required. We recommend reviewing system components with fire alarm vendor on a regular basis. If expansion of system is found to be required, the Reserve Study should be updated and any additional costs should be factored accordingly.

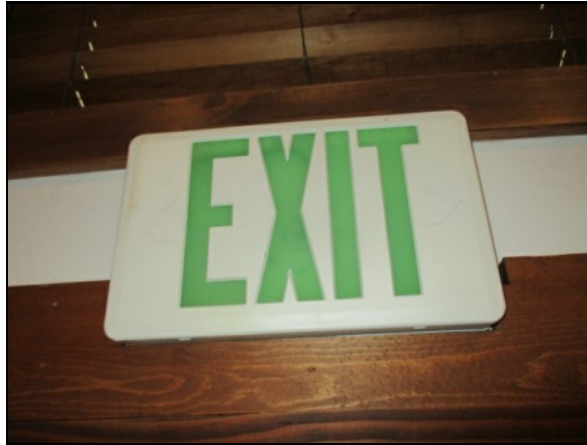
**Comp #: 25420 Exit/Emergency Fixtures - Replace**

Comments: There were nine (9) emergency exit signs on the property. They appeared to be in overall fair condition. Minimal or no subjective/aesthetic value for this component. Useful life is based primarily on normal expectations for service/performance life in this location. Unless otherwise noted, remaining useful life expectancy is based primarily on original installation or last replacement/purchase date, our experience with similar systems/components, and assuming normal amount of usage and good preventive maintenance. In general, costs related to this component are expected to be included in the Association's Operating budget. No recommendation for Reserve funding at this time. However, any repair and maintenance or other related expenditures should be tracked, and this component should be re-evaluated during future Reserve Study updates based on most recent information and data available at that time. If deemed appropriate for Reserve funding, component can be included in the funding plan at that time.

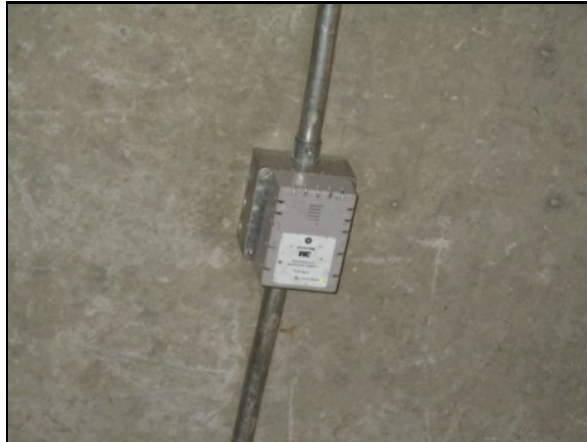
**Comp #: 25430 CO Monitors - Replace**

History: Replaced in 2020 for ~\$20,000.

Comments: Minimal or no subjective/aesthetic value for this component. Useful life is based primarily on normal expectations for service/performance life in this location. Unless otherwise noted, remaining useful life expectancy is based primarily on original installation or last replacement/purchase date, our experience with similar systems/components, and assuming normal amount of usage and good preventive maintenance. Carbon monoxide monitors were not tested for functionality during site inspection.

Should be inspected, tested and individually repaired/replaced as needed by qualified vendor. Funding recommendation shown here provides for replacement of all units together as one project. As with any life safety component, monitors should be kept in good condition and replaced periodically with more modern technology.

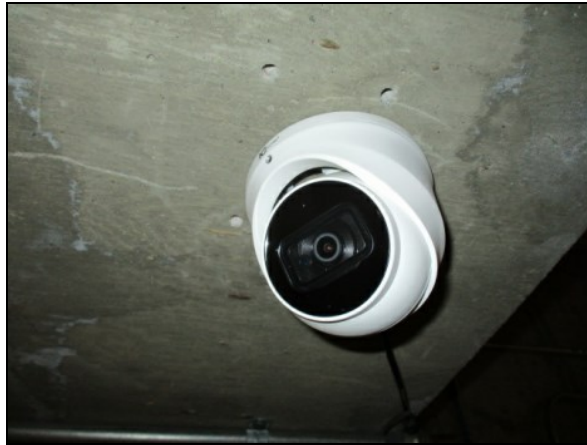
History: Replaced in 2021 for ~\$21,000.

Comments: Includes (16) cameras, (1) DVR. Minimal or no subjective/aesthetic value for this component. Useful life is based primarily on normal expectations for service/performance life in this location. Unless otherwise noted, remaining useful life expectancy is based primarily on original installation or last replacement/purchase date, our experience with similar systems/components, and assuming normal amount of usage and good preventive maintenance. Security/surveillance systems should be monitored closely to ensure proper function. Whenever possible, camera locations should be protected and isolated to prevent tampering and/or theft. Typical modernization projects may include addition and/or replacement of cameras, recording equipment, monitors, software, etc. Unless otherwise noted, costs assume that existing wiring can be re-used and only the actual cameras and other equipment will be replaced. In many cases, replacement or modernization is warranted due to advancement in technology, not necessarily due to functional failure of the existing system. Keep track of any partial replacements and include cost history during future Reserve Study updates.

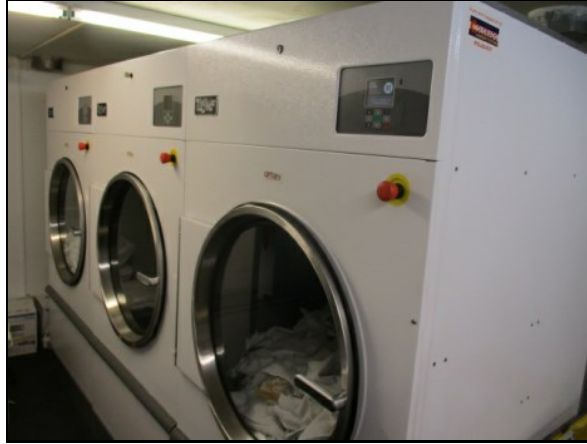
### Comp #: 25320 Commercial Dryers - Replace

Comments: Includes (3) Uni-mac Commercial Dryers. Minimal or no subjective/aesthetic value for this component. Useful life is based primarily on normal expectations for service/performance life in this location. Unless otherwise noted, remaining useful life expectancy is based primarily on original installation or last replacement/purchase date, our experience with similar systems/components, and assuming normal amount of usage and good preventive maintenance. Laundry machines should be inspected, serviced and repaired as needed by vendor and/or staff to ensure full useful life and achieve optimal performance. Useful life expectancy shown here assumes proper preventive maintenance and normal levels of use. Costs to replace are based on replacement with same-size units unless otherwise noted.

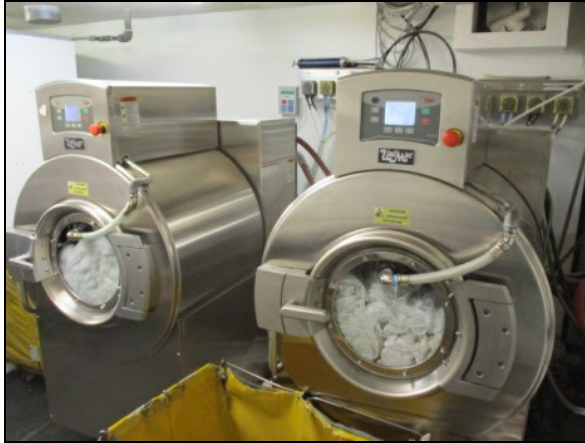
**Comp #: 25320 Commercial Washers - Replace**

History: Replaced in 2022 for \$14,000.

Comments: Includes (2) 65 lb. Uni-Mac Commercial Washers (M: UWN065T4VXU0001, S:1206010256). Minimal or no subjective/aesthetic value for this component. Useful life is based primarily on normal expectations for service/performance life in this location. Unless otherwise noted, remaining useful life expectancy is based primarily on original installation or last replacement/purchase date, our experience with similar systems/components, and assuming normal amount of usage and good preventive maintenance. Laundry machines should be inspected, serviced and repaired as needed by vendor and/or staff to ensure full useful life and achieve optimal performance. Useful life expectancy shown here assumes proper preventive maintenance and normal levels of use. Costs to replace are based on replacement with same-size units unless otherwise noted.

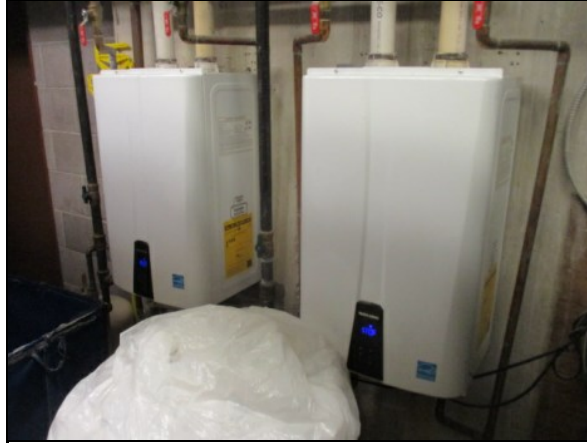
**Comp #: 25460 Tankless Water Heaters - Replace**

Comments: Includes (2) Navien Tankless Water Heaters (M: NPE-240A, S: 7414Z1612041124). Minimal or no subjective/aesthetic value for this component. Useful life is based primarily on normal expectations for service/performance life in this location. Unless otherwise noted, remaining useful life expectancy is based primarily on original installation or last replacement/purchase date, our experience with similar systems/components, and assuming normal amount of usage and good preventive maintenance. Water heater life expectancies can vary greatly depending on level of use, type of technology, amount of preventive maintenance and other factors. Should be inspected and repaired as needed by servicing vendor or maintenance staff. Unless otherwise noted, expected to be functional. Plan to replace at the approximate interval shown below. When evaluating replacements, we recommend choosing high-efficiency or tankless models if possible in order to minimize energy usage.

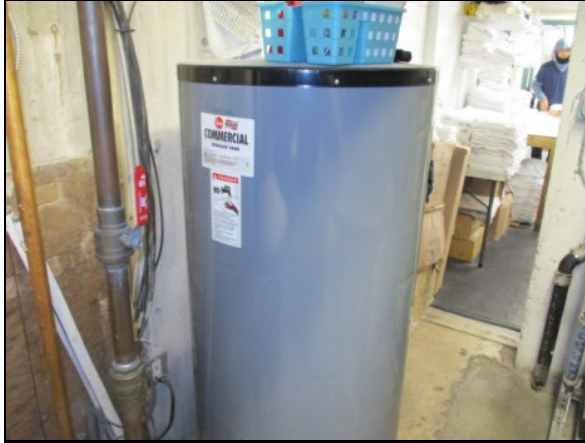
**Comp #: 25460 Water Heater - Replace**

History: Replaced in 2012.

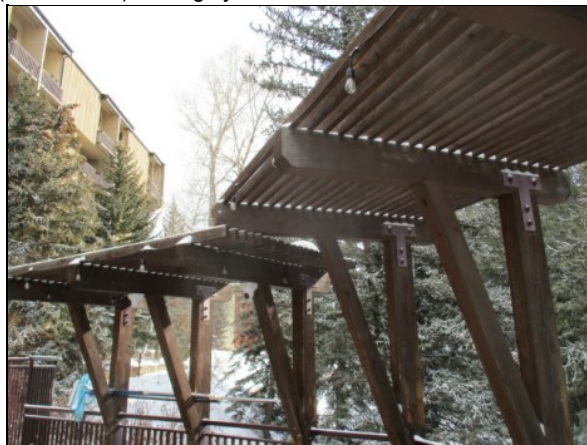
**Comp #: 21430 Pool Pergola - Stain/Paint**

Comments: Fair condition: Pergola structures determined to be in fair condition typically exhibit more wear and tear, possibly including some warped, split and/or deteriorated components. Framework/structure should still be sturdy but may have sections showing minor leaning or damage. As routine maintenance, inspect regularly and repair individual pieces or sections as needed from general Operating funds. Clean and paint/stain along with other larger projects or as general maintenance to preserve the appearance of the pergola and extend its useful life. If present, vegetation should be well-maintained and not allowed to become overgrown, which can eventually compromise the structure. Assuming ordinary care and maintenance, plan for major repairs or possibly complete replacement (if warranted) at roughly the interval indicated below.
