**Antlers at Vail  
Vail, CO**

Report #: 13433-3  
Beginning: October 1, 2023  
Expires: September 30, 2024

**RESERVE STUDY  
Update "With-Site-Visit"**

April 20, 2023

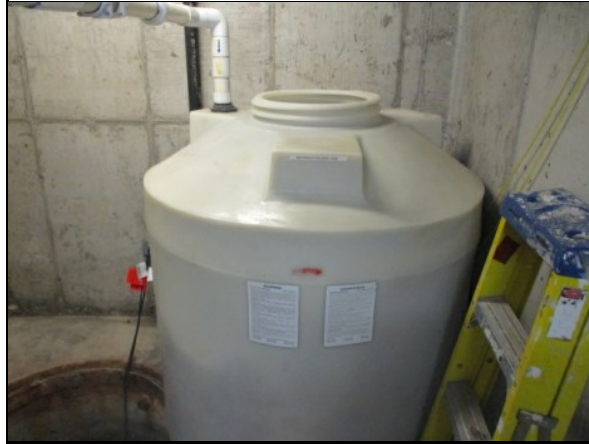
**Comp #: 25470 Backwash Tank - Replace**

Comments: The tank was in operational condition with no reported leaks or problems by the client. In most cases, equipment are repaired or rebuilt as needed as an Operating cost, as expenses involved do not typically meet threshold for Reserve funding.

Plan to repair and replace as needed as an Operating expense, but keep track of any larger projects. This component may need to be re-evaluated during future Reserve Study updates if costs become significant.

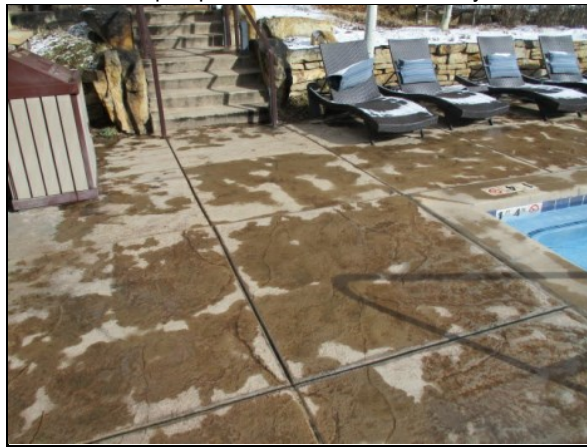
**Comp #: 28050 Snowmelt Deck - Replace**

Comments: Includes ~ (3338 GSF) Snowmelt Pool Decking. Decking was observed to be in fair condition. Deck was not exhibiting major signs of wear and/or age. Pool decks may be exposed to harsh chemicals that can leave stains if not addressed properly. Periodic pressure-washing and repairing will restore the appearance and prolong the need for major restoration or replacement of the deck surface. Take note of any places where water is ponding, which may result in slip-and-fall hazards if not corrected.

This component funds for the removal and replacement of the snow melt lines that lay beneath the concrete. Over time, the lines will deteriorate and will need to be replaced. This project will include tearing out the concrete, removing and re-laying the lines. Snow melt systems should be inspected regularly and repaired as-needed by serving vendor or maintenance staff to ensure proper function and optimal performance. Minor repairs such as pump motor replacements, electronic system parts, etc. should be considered an Operating expense. Plan to replace the entire system at the approximate interval shown below based on our experience and research with similar systems. Total life span can vary based on level of use, preventive maintenance, quality of materials and installation, etc. The snow-melt system revolves around keeping the top surface warm enough to melt falling snow when it contacts the surface instead of letting it pile up. The two popular types of heating systems both work by generating radiant heat underneath the driveway, thus keeping the pavement warm during snowstorms. The first heating method uses an electric current to generate heat on a wire or across a mat, in almost exactly the same manner as most indoor floor-heating systems. The second method uses a series of tubes and pumps to move hot water directly underneath the driveway, warming it up.

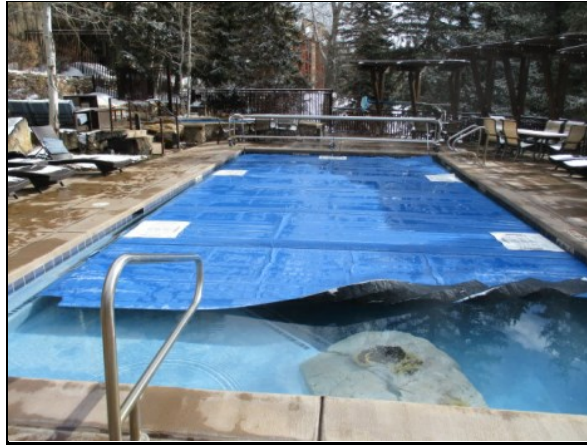
Comments: Pool surfaces exhibited some pitting, chipping, un-even, and broken surfaces. Cracks were observed to be substantial. Approximately 601 GSF footprint area with 106 waterline/perimeter length. Pool resurfacing will restore the aesthetic quality of the pool while protecting the actual concrete shell of the pool from deterioration. While drained for resurfacing, any other repairs to lighting, handrails, stairs, ladders, etc. should be conducted as needed. This type of project is best suited for slow/offseason to minimize downtime during periods when pool is used heavily. Should be expected at the approximate interval shown below in some cases, schedule may need to be accelerated due to improper chemical balances or aesthetic preferences of the client.

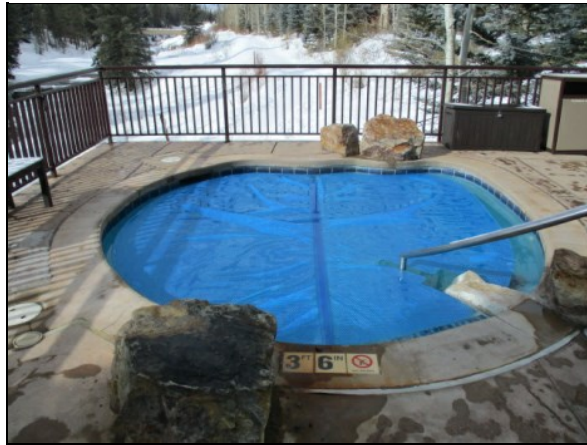
Comments: Includes (1) spa (170 GSF, 50LF Perimeter), (1) spa (112 GSF, 39LF Perimeter). Spa surfaces exhibited considerable pitting, chipping, un-even, and broken surfaces. Cracks were observed to be substantial. Spas sometimes need to be resurfaced more frequently than pools due to higher chance of chemical imbalances. Whenever possible, both should be done at the same time to achieve better pricing and minimize downtime. While drained for resurfacing, any other repairs to lighting, handrails, stairs, ladders, etc. should be conducted as needed. This type of project is best suited for slow/offseason to minimize downtime during periods when spa is used heavily.

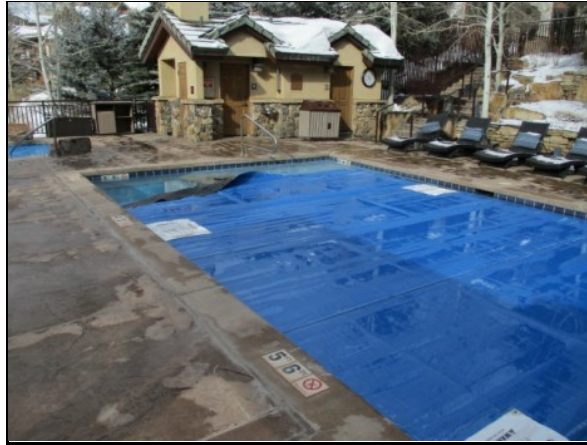
**Comp #: 28140 Pool Cover - Replace**

Comments: Cover was observed to be in poor condition. Fabric was noted to be faded with ripping observed. Inspect regularly and properly store when not in use. Cover can provide cost savings for temperature differentials, reduce cleaning costs and provide safety. We suggest planning to replace at regular intervals to maintain proper functionality.

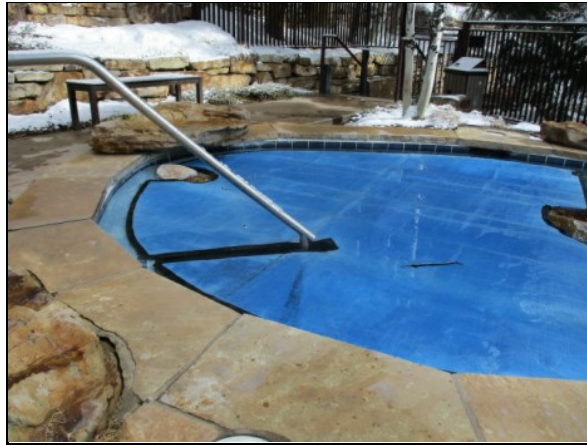
**Comp #: 28150 Spa Cover - Replace**

Comments: Cover was observed to be in poor condition. Fabric was noted to be faded with ripping observed. Inspect regularly and properly store when not in use. Cover can provide cost savings for temperature differentials, reduce cleaning costs and provide safety. We suggest planning to replace at regular intervals to maintain proper functionality.

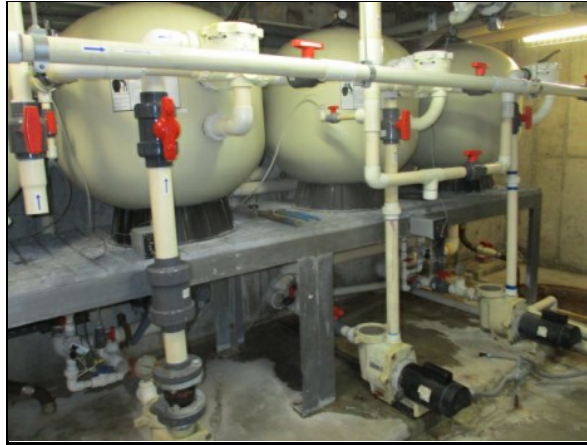
**Comp #: 28190 Pool Filters - Replace**

Comments: Includes (4) Pentair Commercial Pool/Spa Filters (M: TR-140C). Vendor should inspect regularly for optimal performance and address any repairs or preventive maintenance as needed. Life can vary depending on location, as well as level of use and preventive maintenance. Plan to replace at the approximate interval shown below.

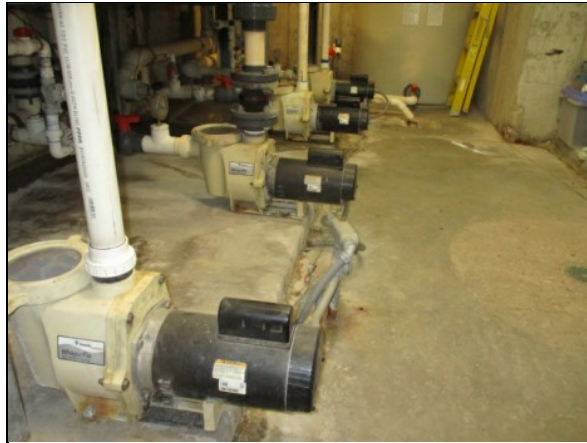
**Comp #: 28220 Pool/Spa Pumps - Repair/Replace**

Comments: Includes (4) Pentair Whisperflo 2HP. Pumps should be inspected regularly for leaks and other mechanical problems. Cost shown is based on replacement with the same type and size unless otherwise noted, and includes small allowance for new piping/valves/other repairs as needed.
